# High Mountain Hearth Solutions, Inc.

## Confidential Inspection Report

### Three Seasons Condominiums

N.F.P.A. Level II Chimney Inspection

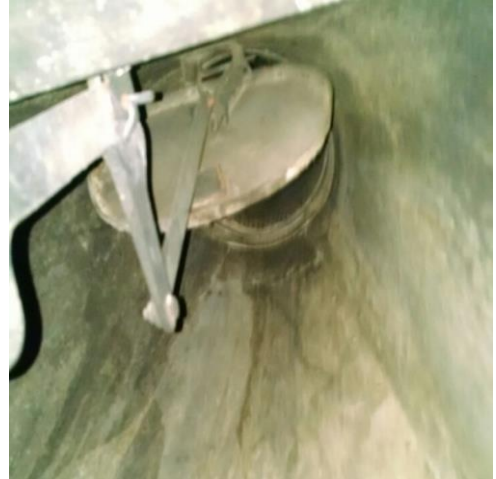
## Fireplace Damper

While the damper in this fireplace appears to function as well as can be expected for a fireplace of this age, it has a tendency to 'stick' and take more force to open and/or close than someone unfamiliar with its operation might think. This could possibly lead to a fire being lit without it being confirmed that the damper is in the full open position. Because of this issue, combined with the other issues found in this inspection, it is recommended that for the protection of life and property, this fireplace and chimney system not be used to burn any type of fire.

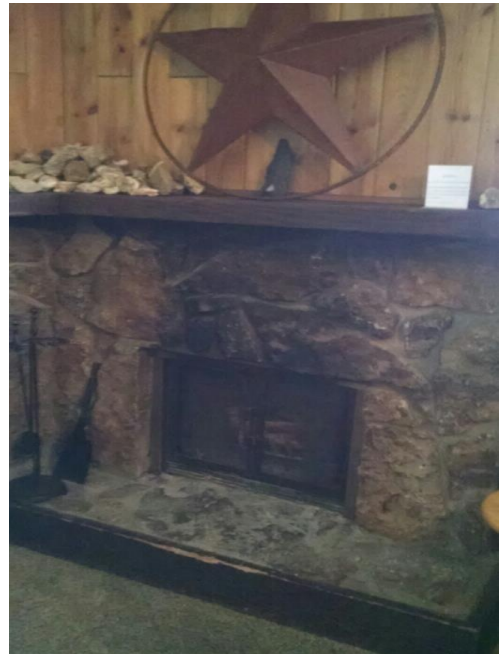
## Smoking Problem

The area above this fireplace opening is stained with smoke. This is evidence of a long term smoking problem due to inadequate draw. The smoke contains harmful gasses that are a byproduct of combustion and should not be allowed to enter the dwelling. Because of this issue, combined with the other issues found in this inspection, it is recommended that for the protection of life and property, this fireplace and chimney system not be used to burn any type of fire.

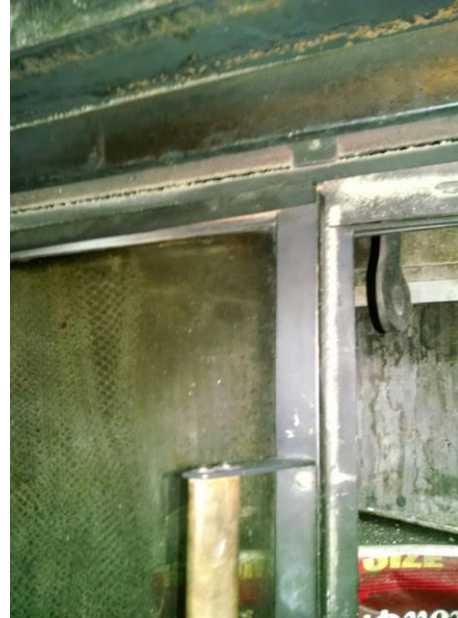
## Fireplace Doors

The doors on this fireplace do not operate correctly. The right door is stuck in the closed position. It is recommended that this issue be corrected. Because of this issue, combined with the other issues found in this inspection, it is recommended that for the protection of life and property, this fireplace and chimney system not be used to burn any type of fire.

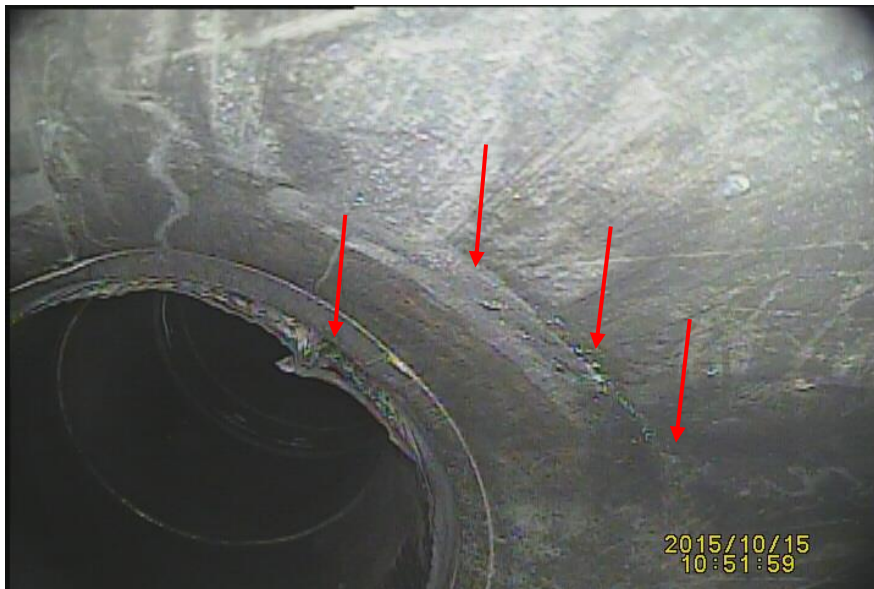
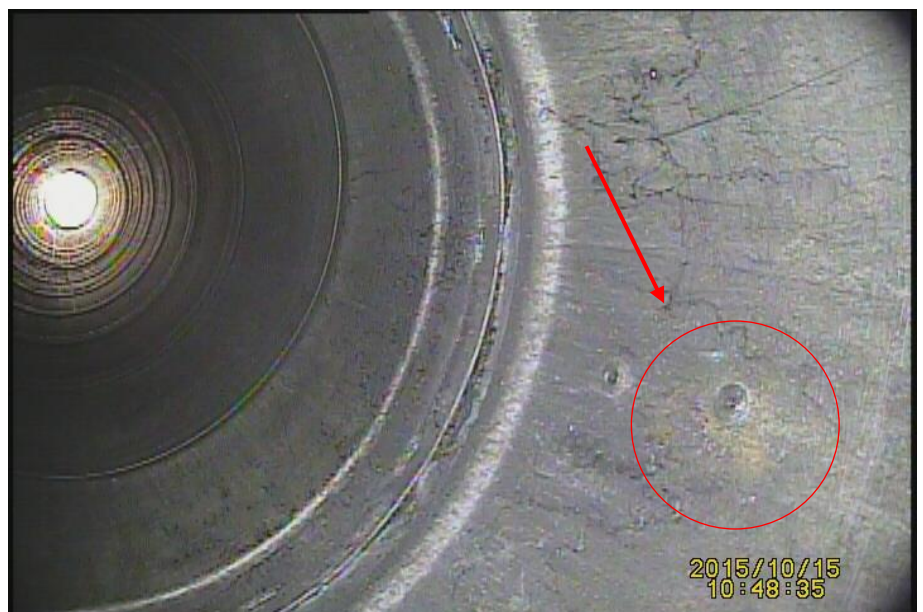
## Interior Chimney Scan

Over time and use, the metals inside the chimney can break down due to the extreme temperatures and the harsh gasses produced during combustion. As seen in the photos below, the video scan of the inside of this chimney shows signs of deterioration and defective joints. This is an area of serious concern, for the protection of life and property, this fireplace and chimney system should not be used for any type of fire.

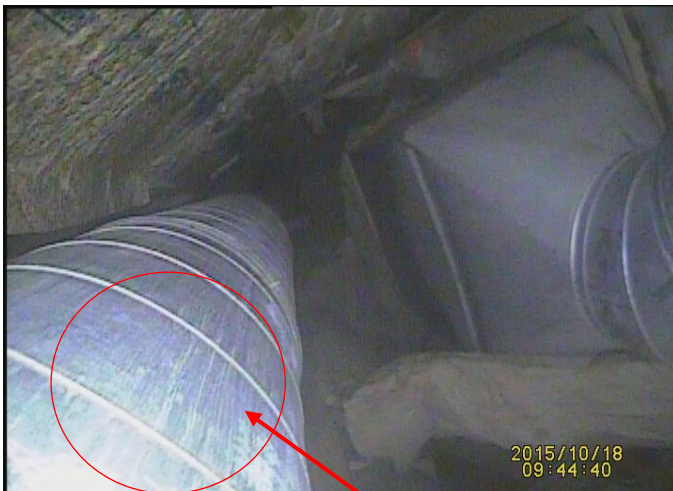
Many of the chimneys in this complex show evidence of moisture on the outside of the outer wall of the chimney. Judging by how the moisture entered and exited the different layers at the joints of the chimneys, it is evident that the moisture has been both on the inside and outside of the outer wall of the chimney. Over time, moisture can break down the integrity of the walls and joints of the chimney, weakening the system and making it unsafe to use. The photos below are representative of the conditions found.

Lines of moisture running in and out of the seams of the outer wall of the chimney

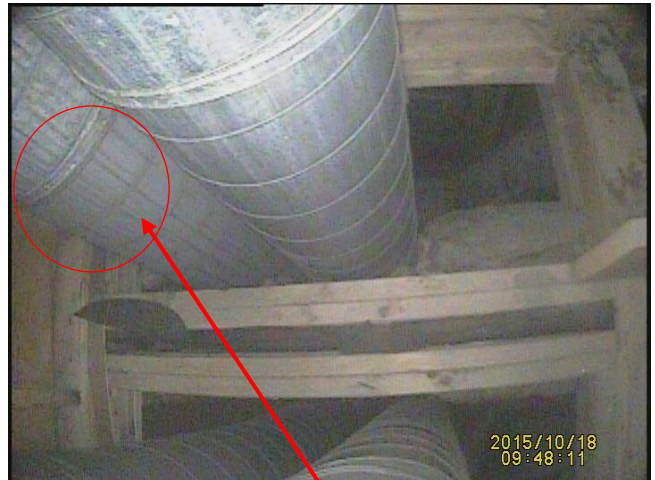
Lines of moisture running in and out of the seams of the outer wall of the chimney

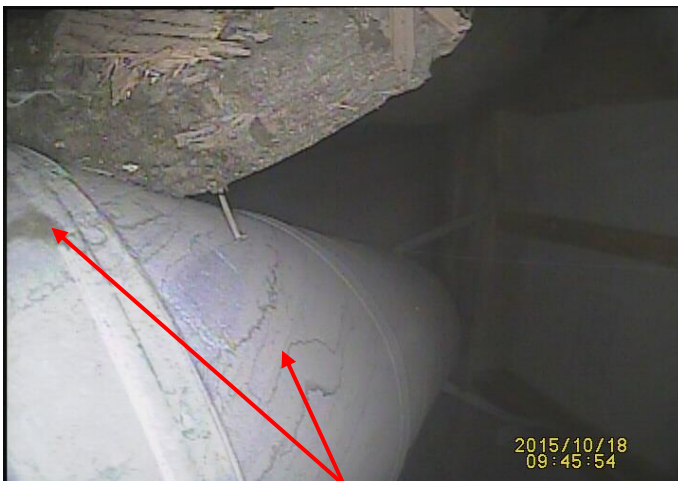
Signs of moisture presents on the outer wall of the chimney

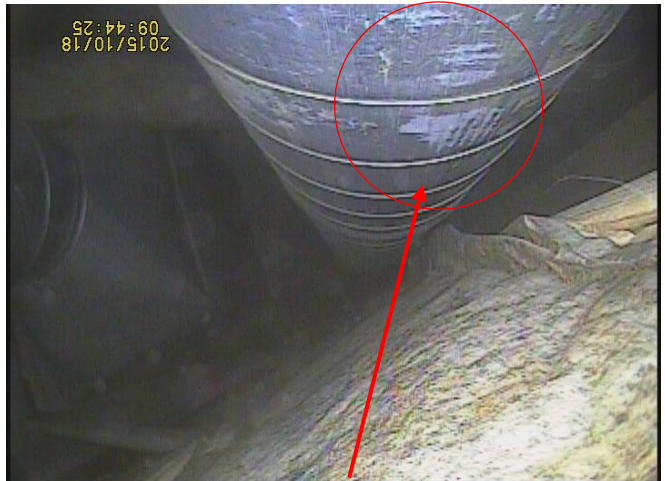
Signs of moisture damage on the outer wall of the chimney

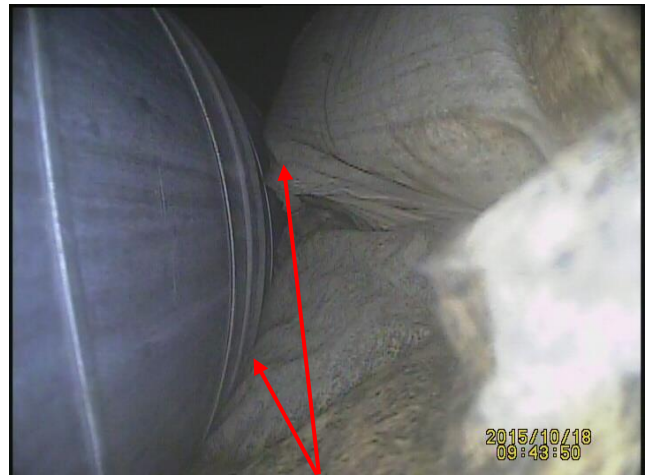
This listed and tested manufactured chimney pipe requires 2" clearance to combustible materials. Inside virtually every chase in the complex, virtually every chimney was in contact with, or had inadequate clearance to, combustible materials. The photos below are representative of the conditions found. This is an area of serious concern, for the protection of life and property, this fireplace and chimney system should not be used for any type of fire.

Combustible insulation in direct contact with the chimney. This is a serious fire hazard

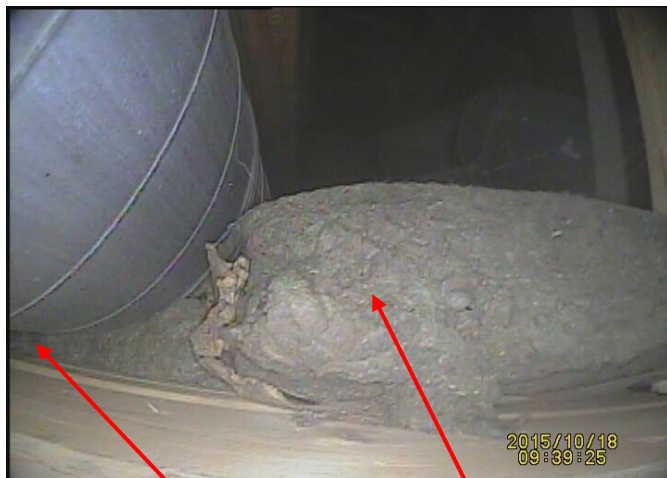
Inadequate clearance to combustible building materials and insulation, which are in direct contact with the chimney. This is a serious fire hazard

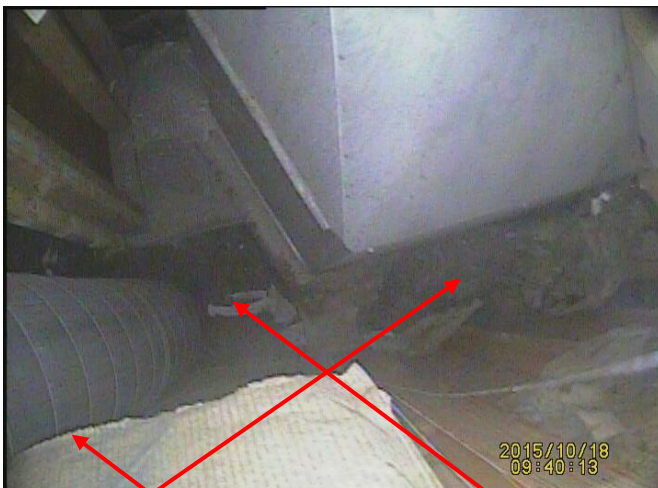
Insulation touching chimney & fireplace, a 2" airspace is required

No firestop provided where chimney passes through floor/ceiling

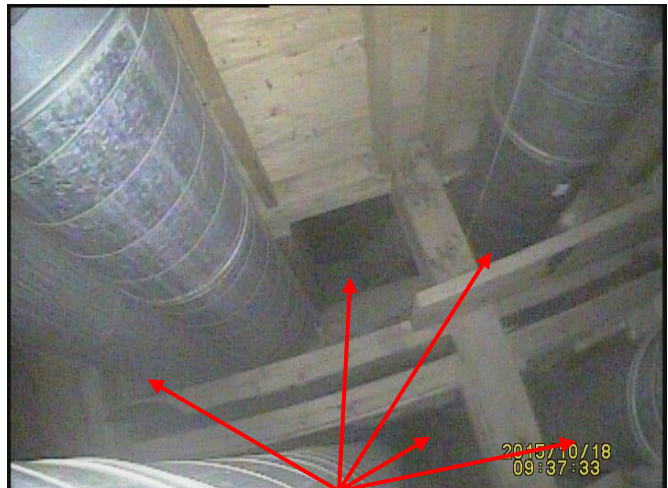
Each chimney must have a firestop where it passes through a floor/ceiling. No firestops have been provided

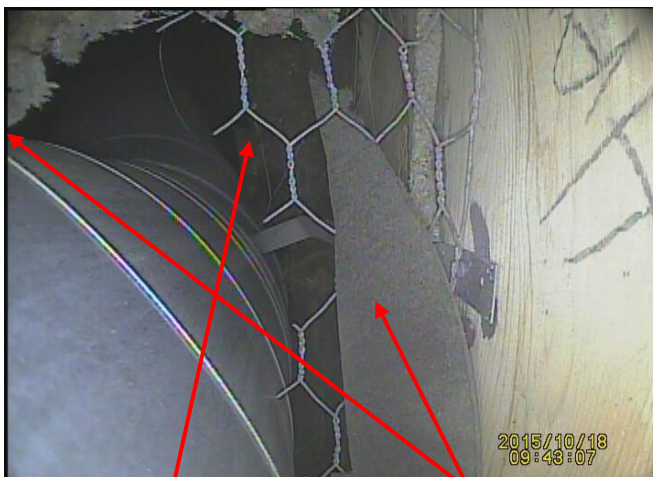
No firestop provided where chimney passes through floor/ceiling

Debris touching chimney, a 2" airspace must be maintained

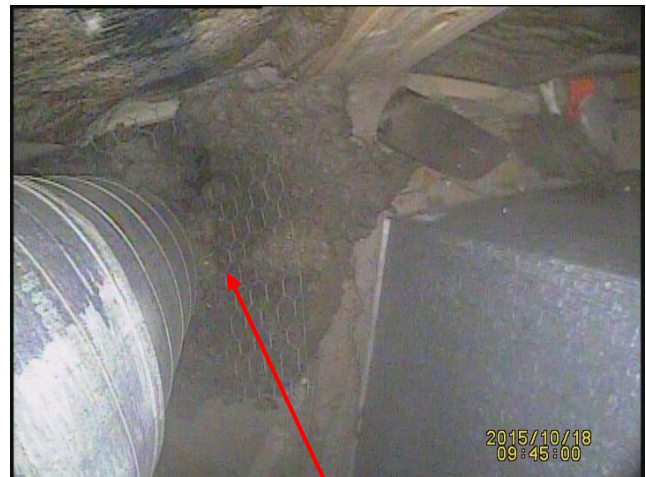
It appears that insulation has been placed on chicken wire in place of an adequate firestop. This is not approved and is a fire hazard

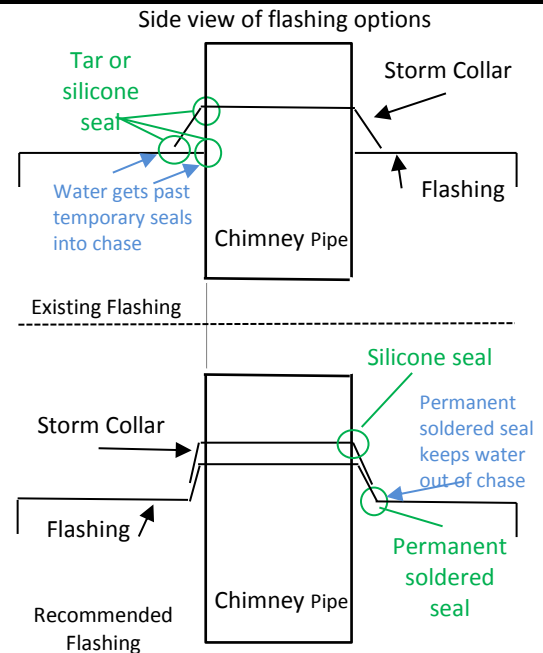
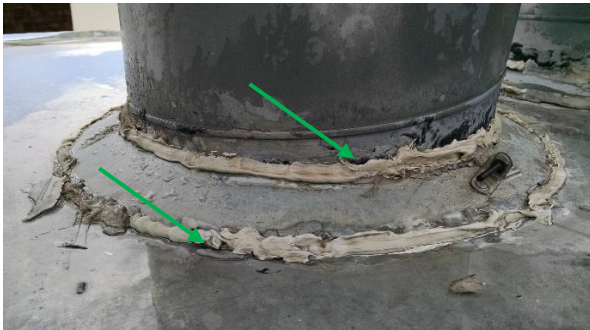
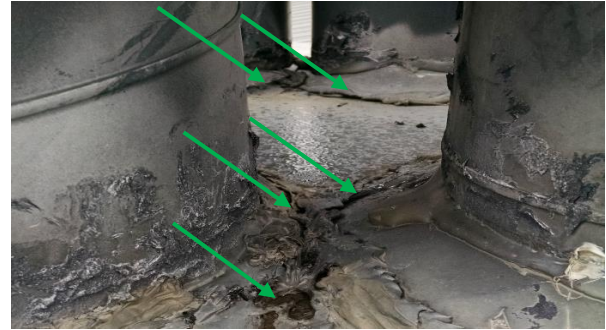
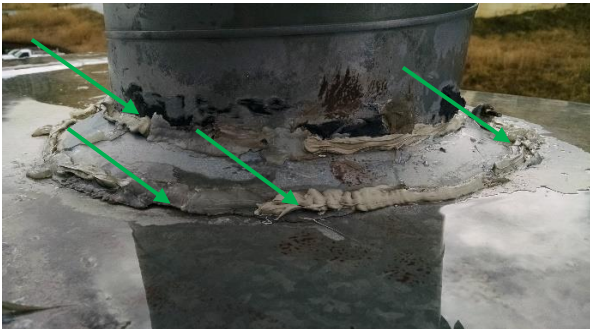
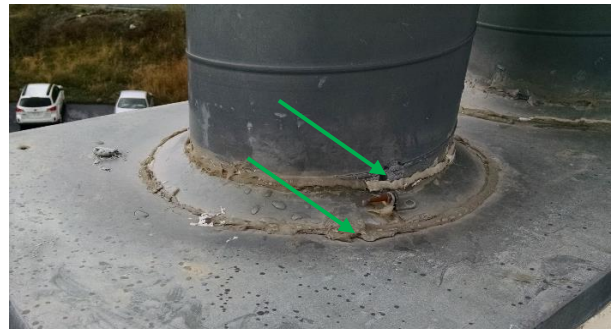
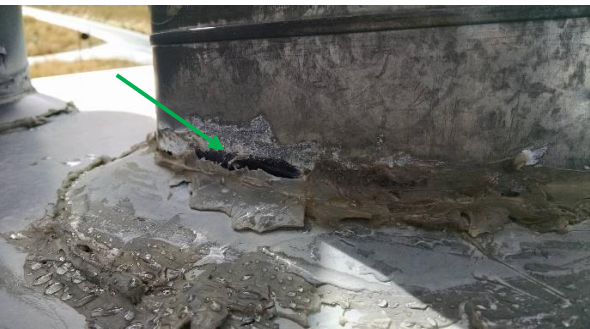
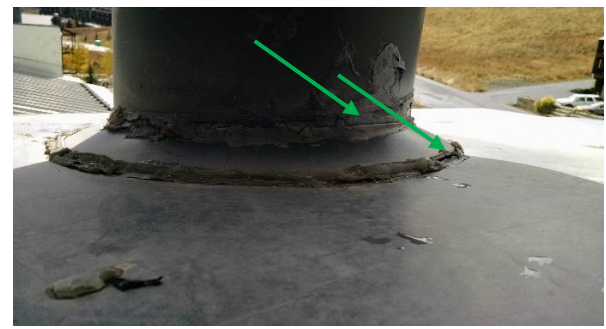
## Chase Top Termination

The storm collar seal on the chimneys in these chases is no longer keeping out all of the moisture. This type of flashing construction relies on temporary seals like tar or silicone to keep moisture from entering the structure, and these components break down over time, as is the case with these chase covers. If constructed differently, a soldered joint is the primary barrier which keeps the moisture out of the chase. A short term fix would be to reseal the existing storm collars, but it is recommended that in the near future the chase covers be replaced with covers that have a soldered collar in place as the primary defense against moisture. The photos below are representative of the conditions found.

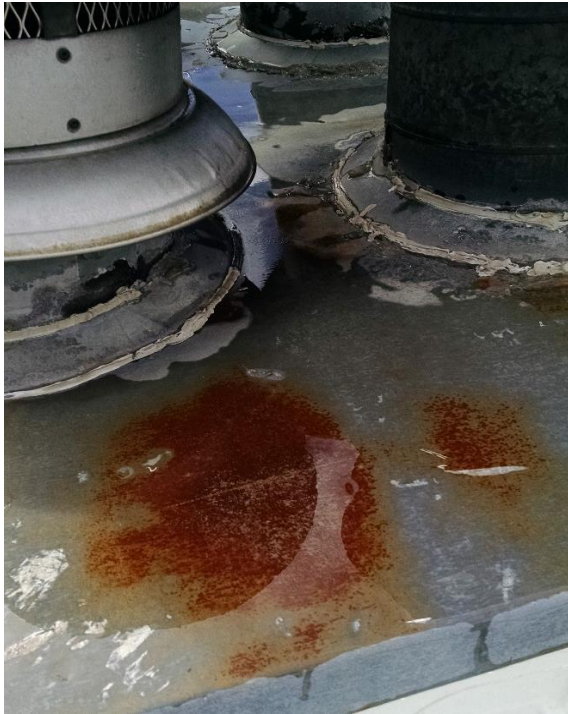
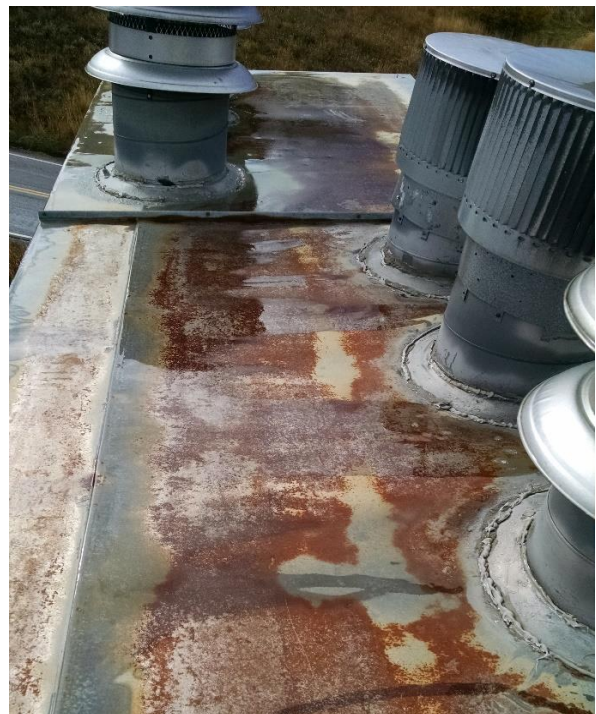
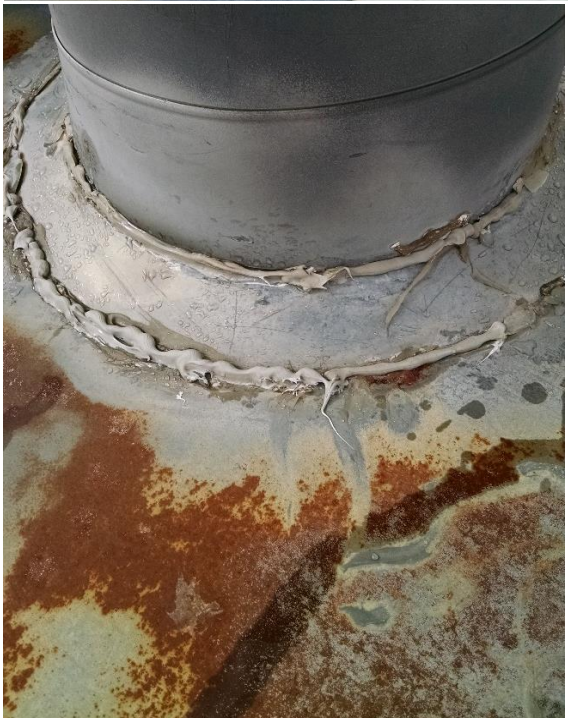
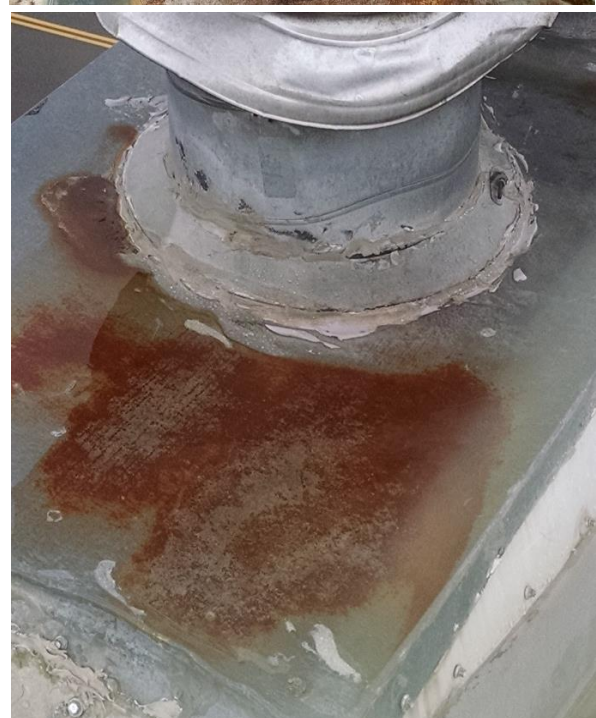
## Chase Top Termination

The photos below show that the metal composing the chase covers on this complex is rusting and deteriorating. At the time of this inspection the covers have not rusted through, but it is recommended that these chase covers be replaced in the near future to prevent property damage. The photos below are representative of the conditions found.
