# High Mountain Hearth Solutions, Inc.

## Confidential Inspection Report

### Three Seasons Condominiums

N.F.P.A. Level II Chimney Inspection

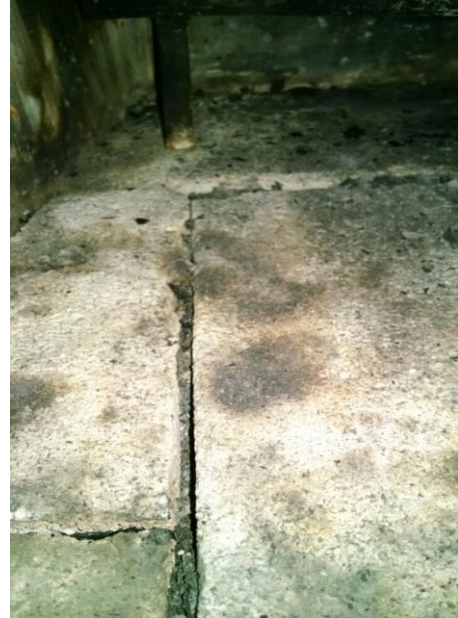
## Firebox Floor

The firebox refractory floor is showing cracks from long term use. The purpose of the refractory floor is to help insulate the combustible building materials beneath the fireplace. Firebricks are installed on top of the refractory floor, which is acceptable except there are large cracks between the bricks which could allow heat and/or sparks down in between the bricks. Long term exposure to excessive heat can lower the ignition temperature of the combustible building materials beneath the fireplace, and what may not have been a safety issue in the past could possibly become a fire hazard. Because of this issue, combined with the other issues found in this inspection, it is recommended that, for the protection of life and property, this fireplace and chimney system not be used to burn any type of fire.

A.14.3 (Chimney inspection required to ensure).....(4) General condition of appliance

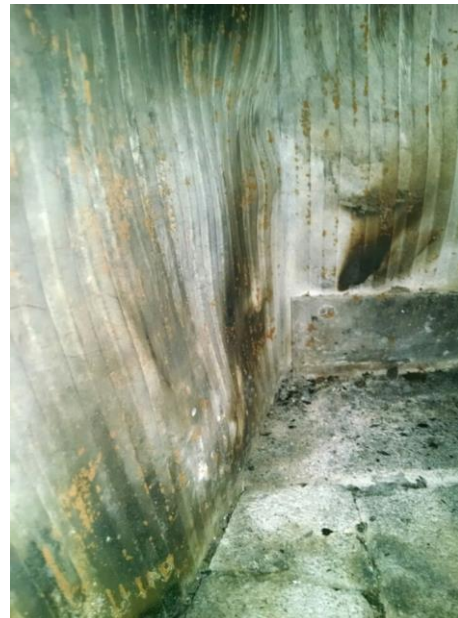
## Firebox Baffles

The firebox baffles on the sides and back of the firebox are warping from long term use. The purpose of the baffles is to help provide an insulating airspace between the firebox and the outside of the fireplace, which is next to the combustible framing of the structure. As the baffles continue to warp, the airspace becomes smaller and misshaped, likely reducing the insulating value the airspace behind the baffles provide. Long term exposure to excessive heat can lower the ignition temperature of the combustible building materials around the fireplace, and what may not have been a safety issue in the past could possibly become a fire hazard. Because of this issue, combined with the other issues found in this inspection, it is recommended that, for the protection of life and property, this fireplace and chimney system not be used to burn any type of fire.

A.14.3 (Chimney inspection required to ensure).....(4) General condition of appliance

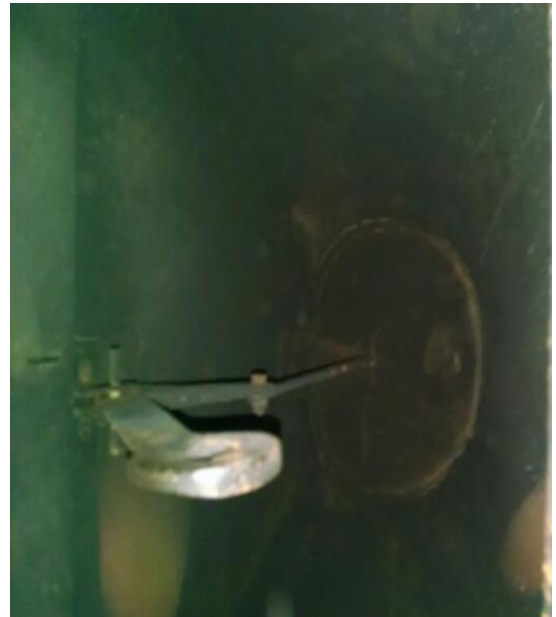
## Fireplace Damper

While the damper in this fireplace appears to function as well as can be expected for a fireplace of this age, it has a tendency to 'stick' and take more force to open and/or close than someone unfamiliar with its operation might think. This could possibly lead to a fire being lit without it being confirmed that the damper is in the full open position. Because of this issue, combined with the other issues found in this inspection, it is recommended that for the protection of life and property, this fireplace and chimney system not be used to burn any type of fire.

A.14.3 (Chimney inspection required to ensure).....(27) Operation and closure of damper assembly

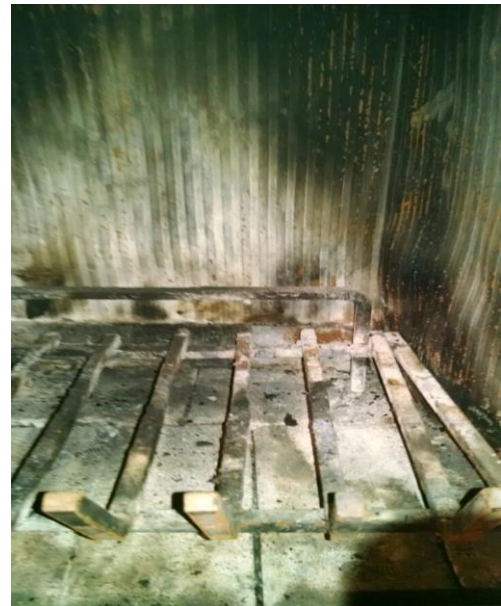
## Fireplace Firebox

The firebox in this fireplace showing rust damage. This rust can breakdown the metals composing the fireplace, making it unable to withstand the temperatures of a wood fire. This creates a fire hazard. Because of this issue, combined with the other issues found in this inspection, it is recommended that for the protection of life and property, this fireplace and chimney system not be used to burn any type of fire.

A.14.3 (Chimney inspection required to ensure).....(32) Freedom from rust or corrosion of readily accessible metal parts in factory-built fireplaces and chimneys

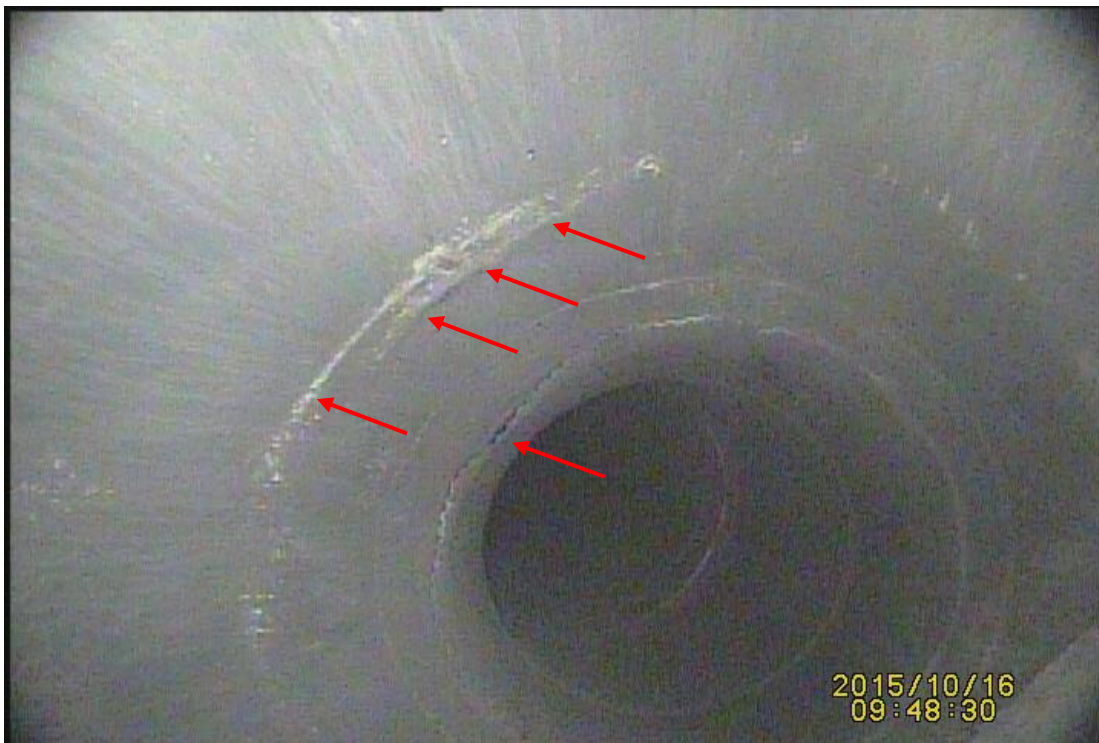
## Interior Chimney Scan

Over time and use, the metals inside the chimney can break down due to the extreme temperatures and the harsh gasses produced during combustion. As seen in the photos below, the video scan of the inside of this chimney shows signs of deterioration, as well as unsecure joints. This is an area of serious concern, for the protection of life and property, this fireplace and chimney system should not be used for any type of fire.

A.14.3 (Chimney inspection required to ensure).....(5) Chimney or vent and its connector for general suitability....
