# High Mountain Hearth Solutions, Inc.

## Confidential Inspection Report

### Three Seasons Condominiums

N.F.P.A. Level II Chimney Inspection

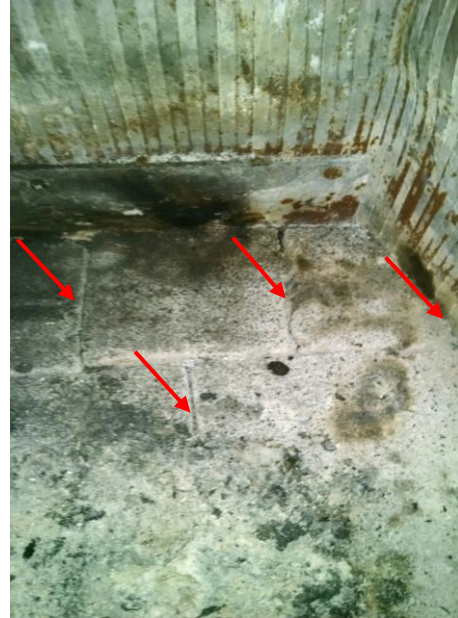
The firebox refractory floor is showing cracks from long term use. The purpose of the refractory floor is to help insulate the combustible building materials beneath the fireplace. Firebricks are installed on top of the refractory floor, which is acceptable except there are large cracks between the bricks which could allow heat and/or sparks down in between the bricks. Long term exposure to excessive heat can lower the ignition temperature of the combustible building materials beneath the fireplace, and what may not have been a safety issue in the past could possibly become a fire hazard. Because of this issue, combined with the other issues found in this inspection, it is recommended that, for the protection of life and property, this fireplace and chimney system not be used to burn any type of fire.

A.14.3 (Chimney inspection required to ensure).....(4) General condition of appliance

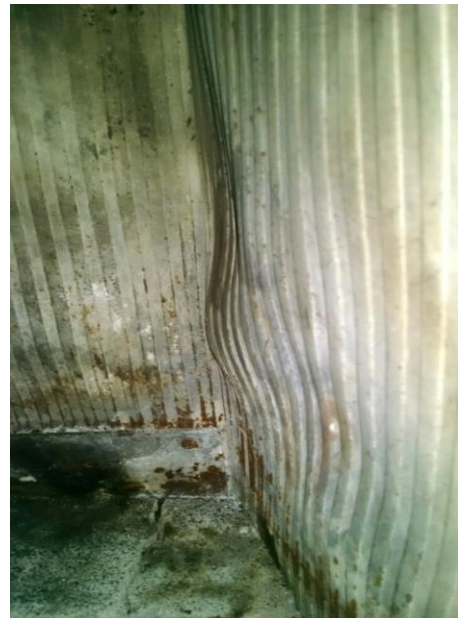
The firebox baffles on the sides and back of the firebox are warping from long term use. The purpose of the baffles is to help provide an insulating airspace between the firebox and the outside of the fireplace, which is next to the combustible framing of the structure. As the baffles continue to warp, the airspace becomes smaller and misshaped, likely reducing the insulating value the airspace behind the baffles provide. Long term exposure to excessive heat can lower the ignition temperature of the combustible building materials around the fireplace, and what may not have been a safety issue in the past could possibly become a fire hazard. Because of this issue, combined with the other issues found in this inspection, it is recommended that, for the protection of life and property, this fireplace and chimney system not be used to burn any type of fire.

A.14.3 (Chimney inspection required to ensure).....(4) General condition of appliance

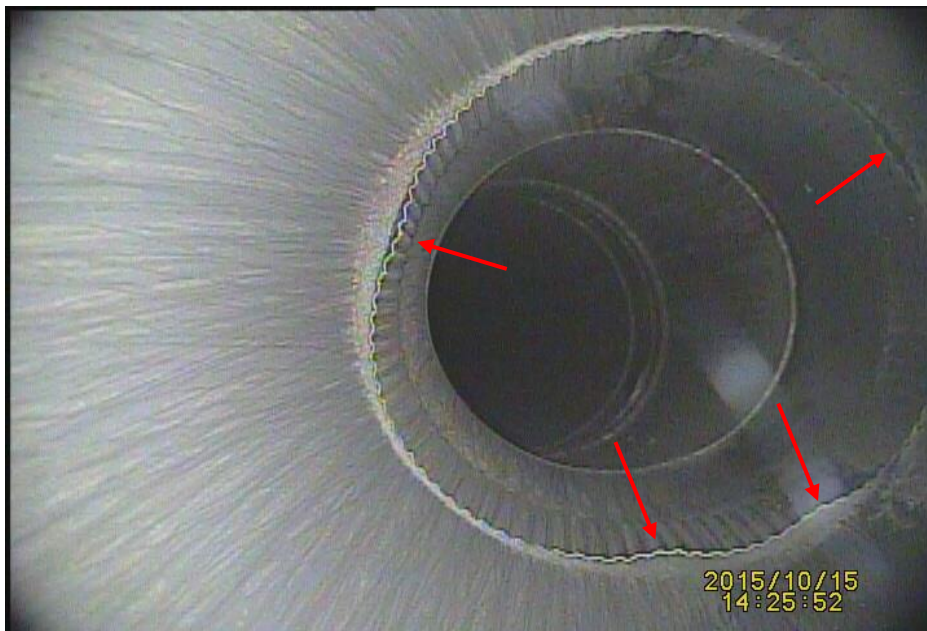
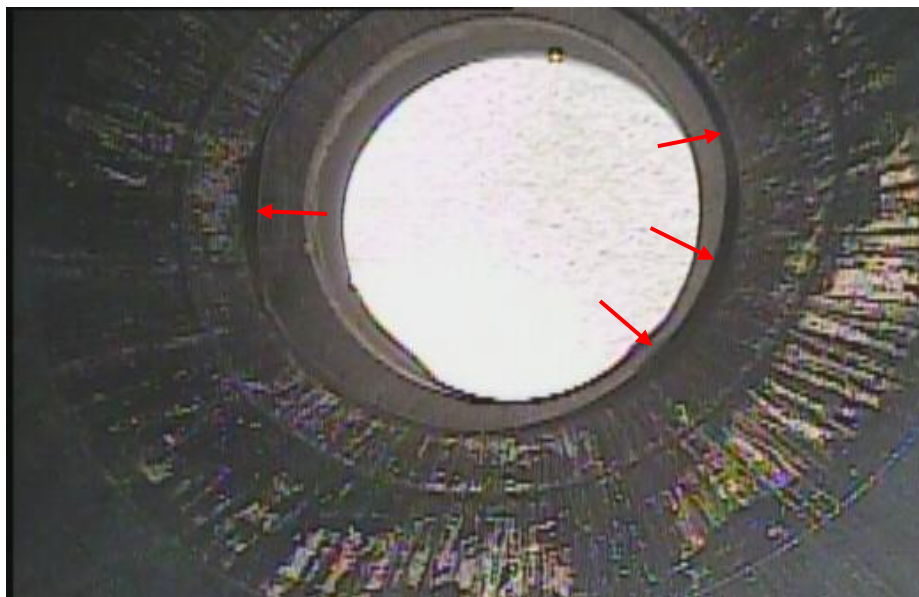
Over time and use, the metals inside the chimney can break down due to the extreme temperatures and the harsh gasses produced during combustion. As seen in the photos below, the video scan of the inside of this chimney shows defective joints. This is an area of serious concern, for the protection of life and property, this fireplace and chimney system should not be used for any type of fire.

A.14.3 (Chimney inspection required to ensure).....(5) Chimney or vent and its connector for general suitability....

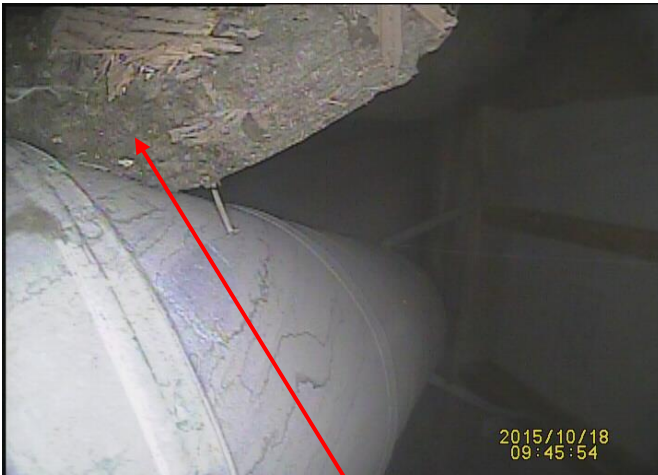
This listed and tested manufactured chimney pipe requires 2" clearance to combustible materials. Inside virtually every chase in the complex, virtually every chimney was in contact with, or had inadequate clearance to, combustible materials. The photos below are representative of the conditions found. This is an area of serious concern, for the protection of life and property, this fireplace and chimney system should not be used for any type of fire.

Combustible building material in direct contact with the chimney. This is a serious fire hazard

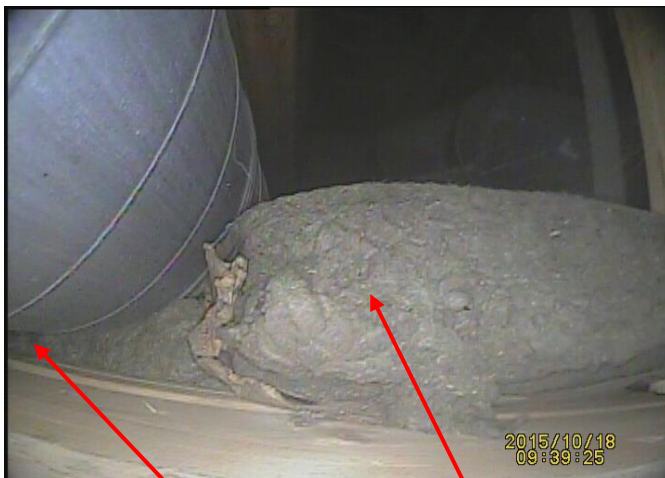
Inadequate clearance to combustible building materials and insulation, which are in direct contact with the chimney. This is a serious fire hazard

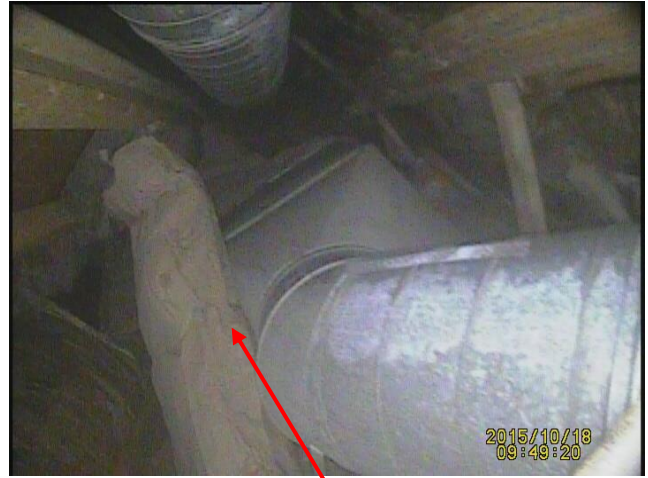
Insulation has fallen on top of a fireplace. This is a serious fire hazard

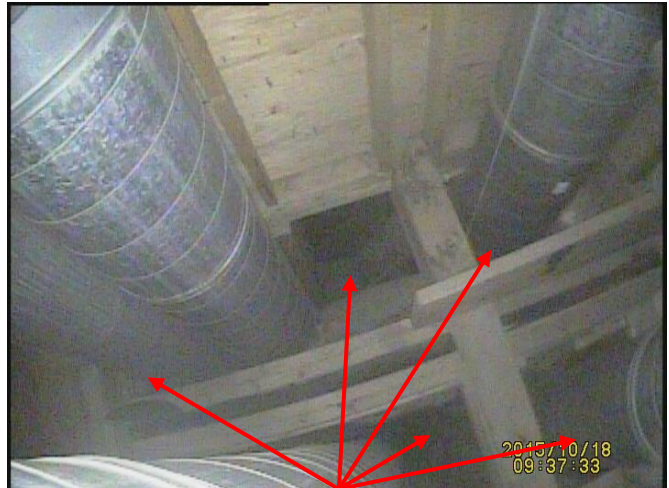
Each time a chimney passes through a floor or ceiling a firestop is required to prevent or slow the spread of flames and smoke in the unfortunate event of a fire. Units on the first floor should have 3 firestops, one at the first floor ceiling, second floor ceiling, and third floor ceiling. Second floor units should have two firestops, and third floor units should have one. Throughout the entire complex we found virtually no adequate firestops. The photos below are representative of the conditions found. This is an area of real concern, for the protection of life and property, this fireplace and chimney system should not be used for any type of fire.

Each chimney must have a firestop where it passes through a floor/ceiling. No firestops have been provided

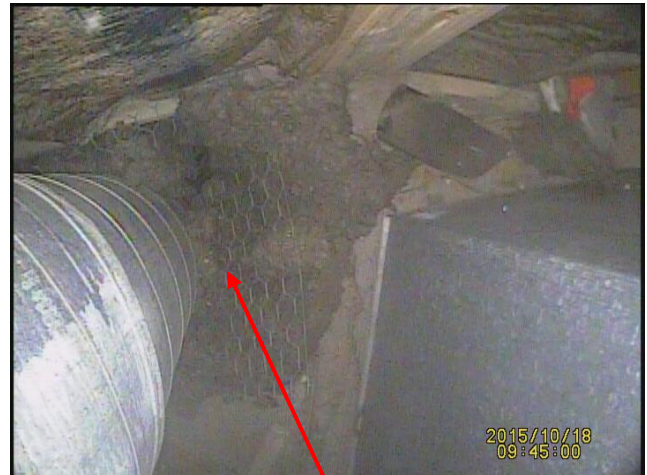
It appears that insulation has been placed on chicken wire in place of an adequate firestop. This is not approved and is a fire hazard
