# High Mountain Hearth Solutions, Inc.

## Confidential Inspection Report

### Three Seasons Condominiums

N.F.P.A. Level II Chimney Inspection

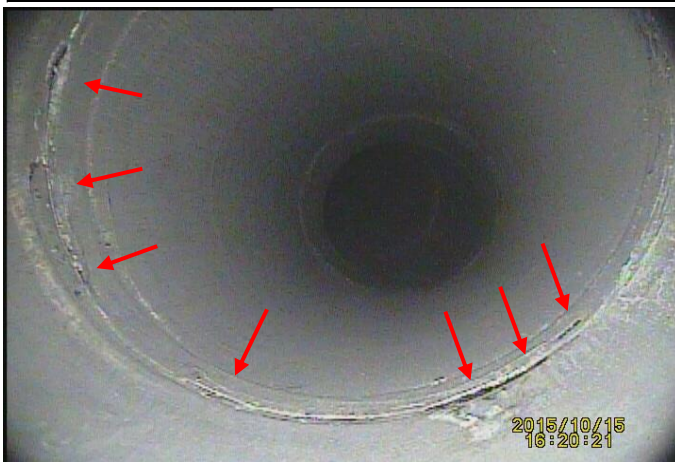
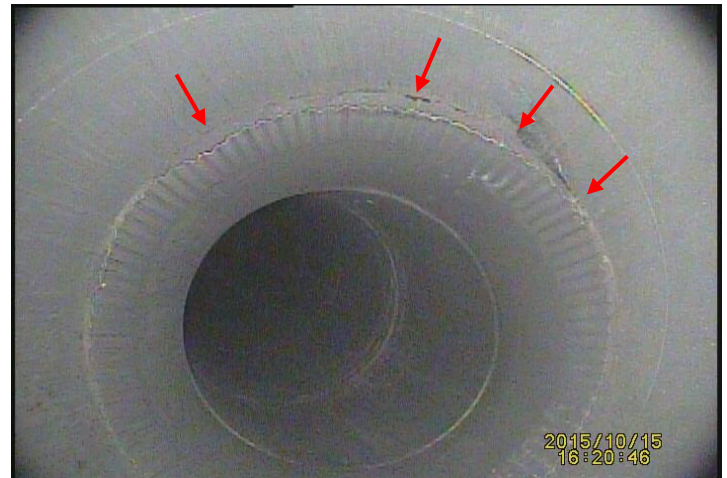
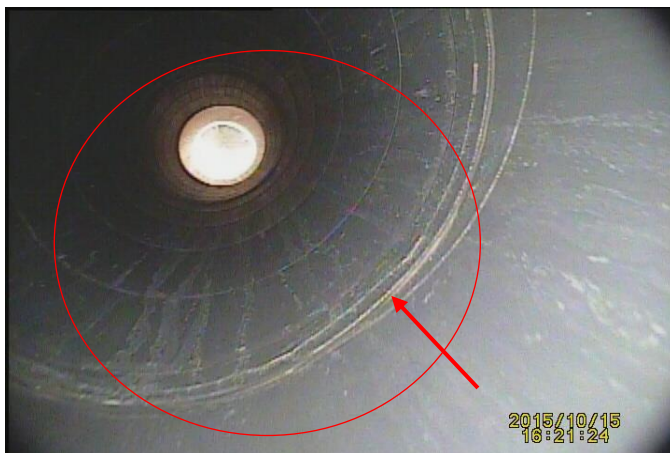
Over time and use, the metals inside the chimney can break down due to the extreme temperatures and the harsh gasses produced during combustion. As seen in the photos below, the video scan of the inside of this chimney shows signs of deterioration, water marks, and defective joints. This is an area of serious concern, for the protection of life and property, this fireplace and chimney system should not be used for any type of fire.

A.14.3 (Chimney inspection required to ensure).....(5) Chimney or vent and its connector for general suitability....
