# High Mountain Hearth Solutions, Inc.

## Confidential Inspection Report

### Three Seasons Condominiums

N.F.P.A. Level II Chimney Inspection

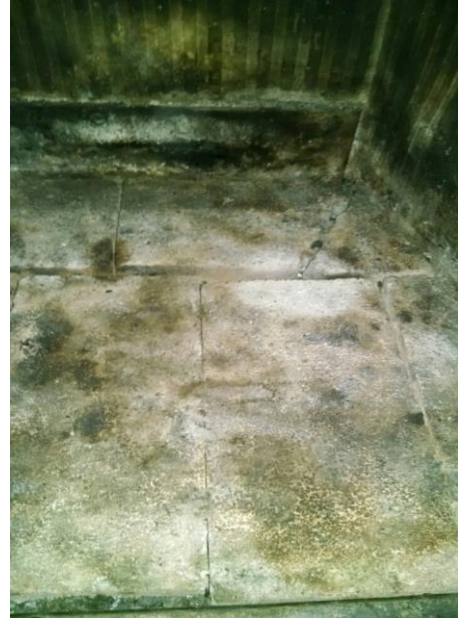
## Firebox Floor

The firebox refractory floor is showing cracks from long term use. The purpose of the refractory floor is to help insulate the combustible building materials beneath the fireplace. Firebricks are installed on top of the refractory floor, which is acceptable except there are large cracks between the bricks which could allow heat and/or sparks down in between the bricks. Long term exposure to excessive heat can lower the ignition temperature of the combustible building materials beneath the fireplace, and what may not have been a safety issue in the past could possibly become a fire hazard. Because of this issue, combined with the other issues found in this inspection, it is recommended that, for the protection of life and property, this fireplace and chimney system not be used to burn any type of fire.

A.14.3 (Chimney inspection required to ensure).....(4) General condition of appliance

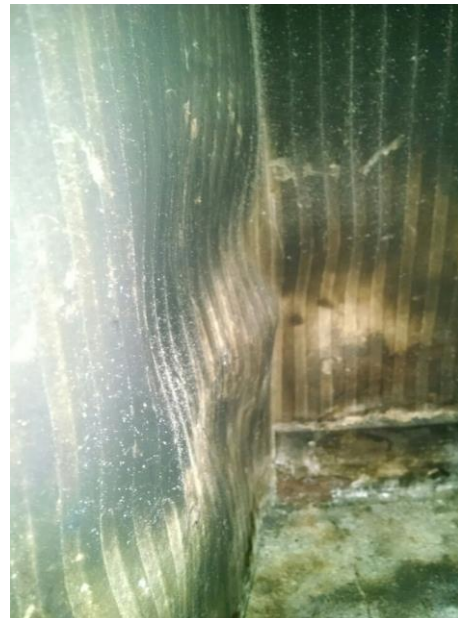
## Firebox Baffles

The firebox baffles on the sides and back of the firebox are warping from long term use. The purpose of the baffles is to help provide an insulating airspace between the firebox and the outside of the fireplace, which is next to the combustible framing of the structure. As the baffles continue to warp, the airspace becomes smaller and misshaped, likely reducing the insulating value the airspace behind the baffles provide. Long term exposure to excessive heat can lower the ignition temperature of the combustible building materials around the fireplace, and what may not have been a safety issue in the past could possibly become a fire hazard. Because of this issue, combined with the other issues found in this inspection, it is recommended that, for the protection of life and property, this fireplace and chimney system not be used to burn any type of fire.

A.14.3 (Chimney inspection required to ensure).....(4) General condition of appliance

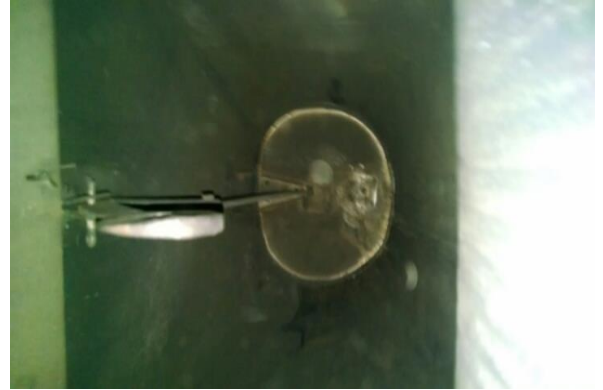
## Fireplace Damper

While the damper in this fireplace appears to function as well as can be expected for a fireplace of this age, it has a tendency to 'stick' and take more force to open and/or close than someone unfamiliar with its operation might think. This could possibly lead to a fire being lit without it being confirmed that the damper is in the full open position. Because of this issue, combined with the other issues found in this inspection, it is recommended that for the protection of life and property, this fireplace and chimney system not be used to burn any type of fire.

A.14.3 (Chimney inspection required to ensure).....(27) Operation and closure of damper assembly

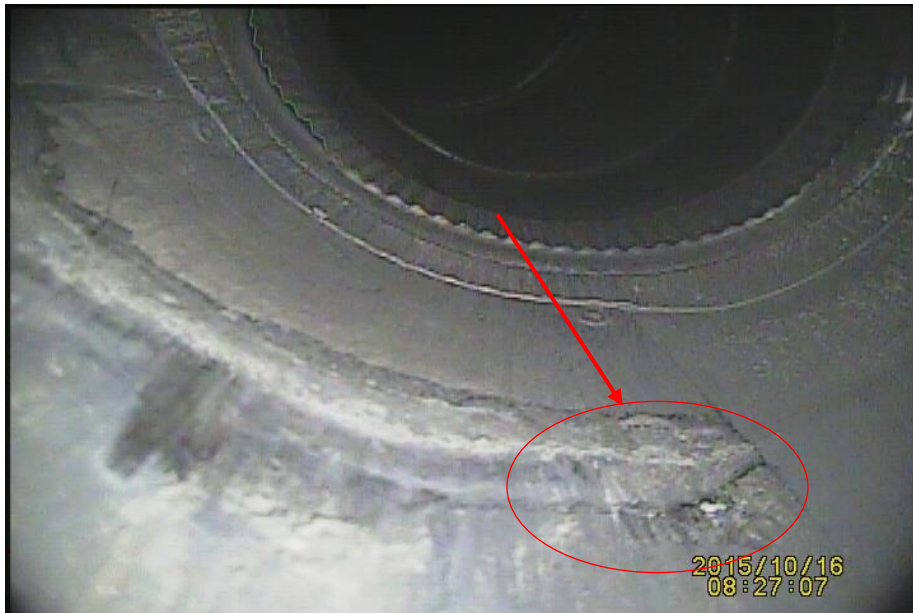
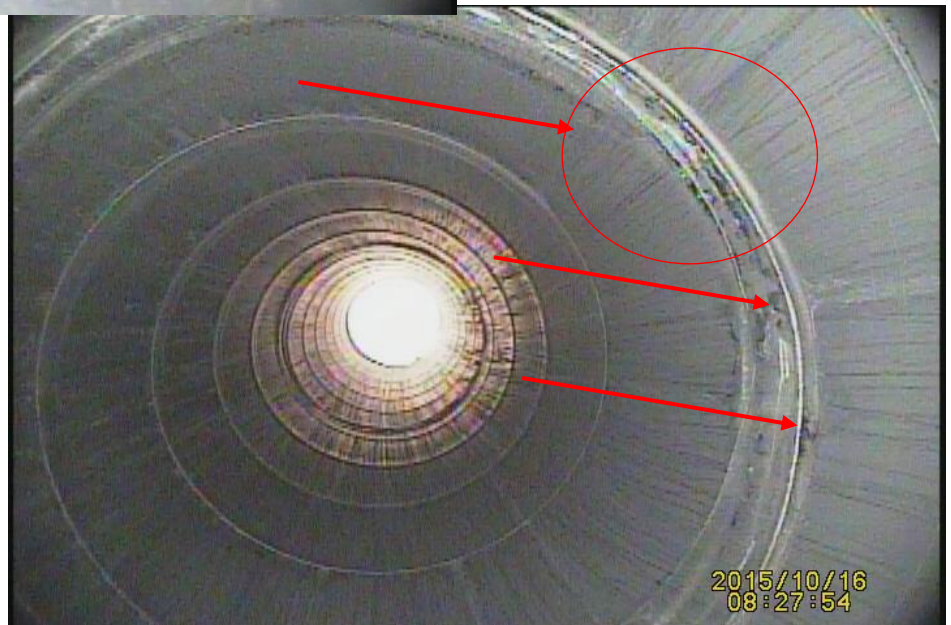
## Interior Chimney Scan

Over time and use, the metals inside the chimney can break down due to the extreme temperatures and the harsh gasses produced during combustion. As seen in the photos below, the video scan of the inside of this chimney shows signs of deterioration. This is an area of serious concern, for the protection of life and property, this fireplace and chimney system should not be used for any type of fire.

A.14.3 (Chimney inspection required to ensure).....(5) Chimney or vent and its connector for general suitability....
